Tidal Page

News of the Rhode Island Salt Ponds

Winter 2012/2013

Hurricane Sandy Pounds Southern RI-- and Opens Our Eyes

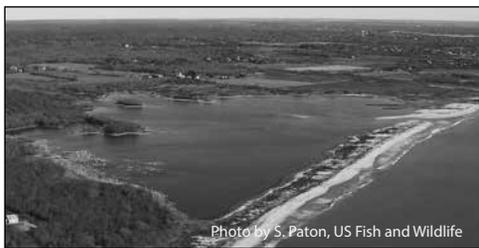
Photo by S. Paton, US Fish and Wildlife

Trustom Pond breached for the first time in about six years thanks to the storm surge and huge waves of Hurricane Sandy.

the mid-2000s, it had gradually become a freshwater ecosystem. Only freshwater fishes such as sunfish and largemouth bass were present, along with freshwater aquatic plants including the invasive Eurasian milfoil. The pond was exhibiting signs of impaired water quality, including low water clarity, algal blooms, elevated nutrients, and high bacteria counts (S. Faubl, *A Management-Oriented Water Quality Investigation of Trustom Pond National Wildlife Refuge*).

Because Trustom Pond is located within a National Wildlife Refuge, Salt Ponds Coalition does not perform water quality monitoring there. However, the US FWS has been monitoring the pond for many years and will continue to study the pond and breach. FWS is also consulting with experts about when the breach may close naturally by deposition of sand transported along the shore. FWS biologists are studying waterfowl populations in the pond, and next summer will conduct studies of aquatic vegetation and fish populations

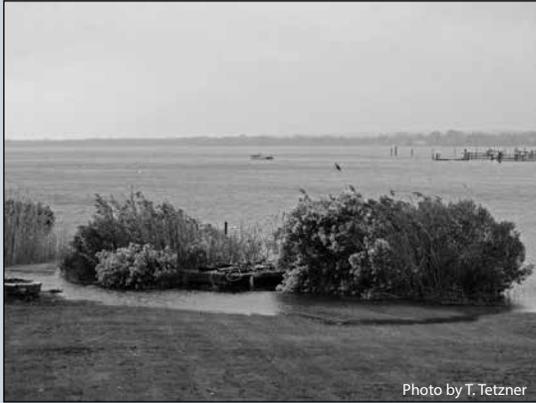
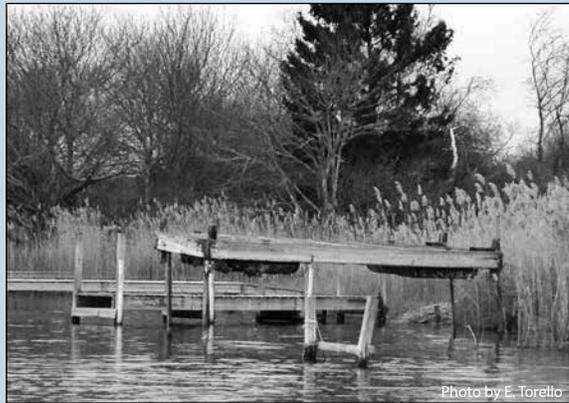
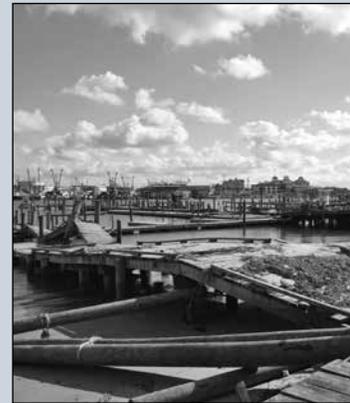
The high storm surge from Hurricane Sandy, on top of a full-moon spring tide, caused significant damage to private and commercial docks within Ninigret Pond. Center photo: Green Hill Pond. Right photo: Jim's Dock, Pt. Judith Pond.

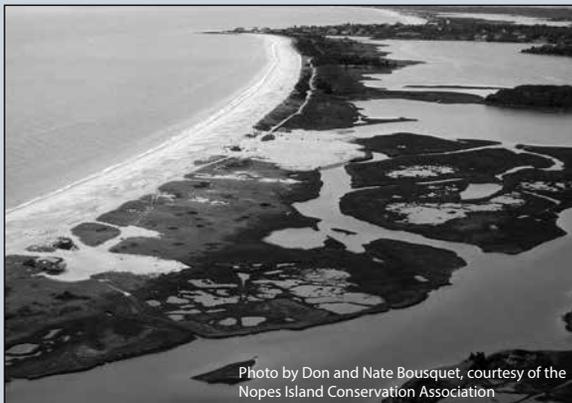
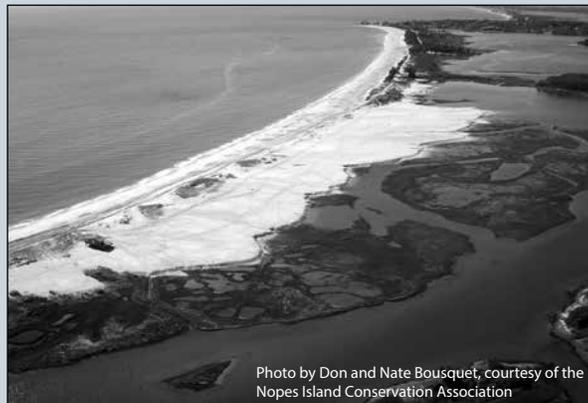
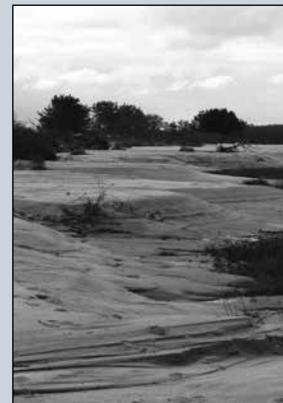
The storm surge from Sandy caused significant overwash of sand onto the coastal barriers which separate the salt ponds from the ocean. The two (middle), show the Quonochontaug Barrier before and after the storm. Note the location of the "slip slope", or pondward boundary of the overwash, respectively at lower left of each photo. The top of the slip-slop indicates the high-water level in the pond--this is where the storm surge dropped sand when it receded (above right). Also note that Japanese black pines planted on the western end of the barrier (top of photos) prevented sand from washing over, creating a "reflective" rather than "dissipative" dune front. Sand also washed over the Green Hill Barrier (below, left) and East Matunuck beach in front of Pt. Judith Pond but did not reach the ponds. Surprisingly, most of the major overwash on the Misquamicut Barrier (below, right) also did not appear to reach Windward Pond.

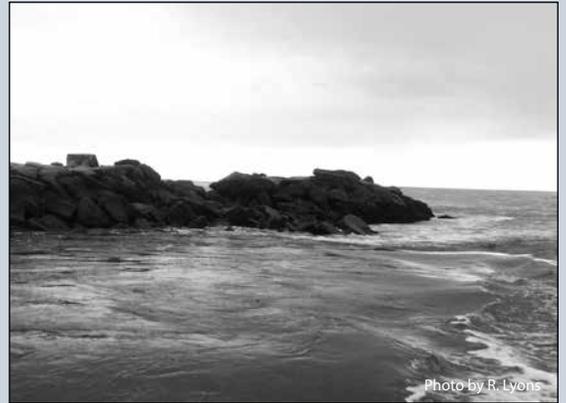
Pounding storm waves pushed large rocks from the east wall of the Charlestown Breachway into the channel. FEMA funds are being sought to repair the damage.

More challenging and potentially more expensive damage to the Charlestown Breachway resulted from the pounding of storm waves against the east wall of the channel. According to Coastal Pond Management Commission chairman Rob Lyons, a number of rocks were pushed into the channel from the wall. This is causing parts of the wall to be nearly underwater at high tide, and the wall is no longer safe for fishermen to walk on. Charlestown and the State of RI are also applying for

FEMA funds to pay for the removal of the rocks from the channel and for the repair of the breachway walls.

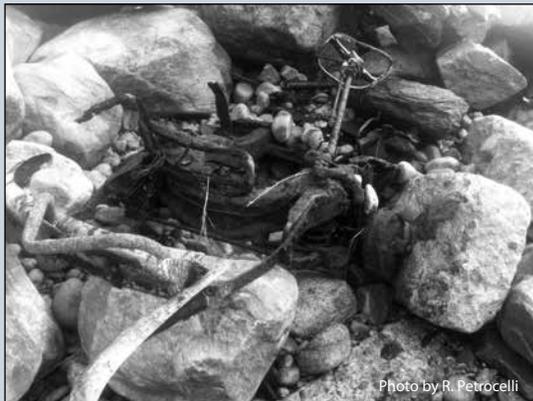
Photo by R. Petrocelli

The pounding waves in Misquamicut revealed an...interesting...method of dune-building used after the Great Hurricane of 1938. The car even had low miles!

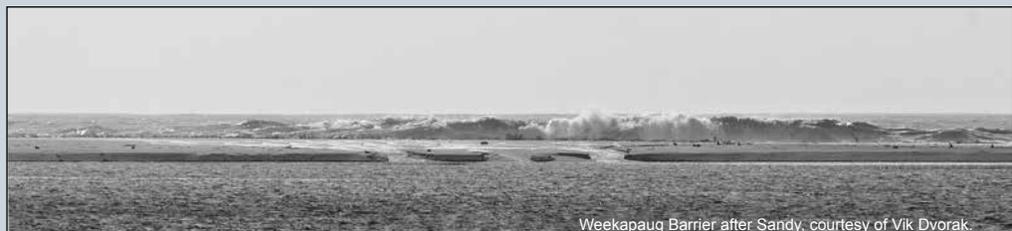
The photo below shows storm waves and overwash on the much flatter Weekapaug Barrier beach.

Weekapaug Barrier after Sandy, courtesy of VIK Dvorak

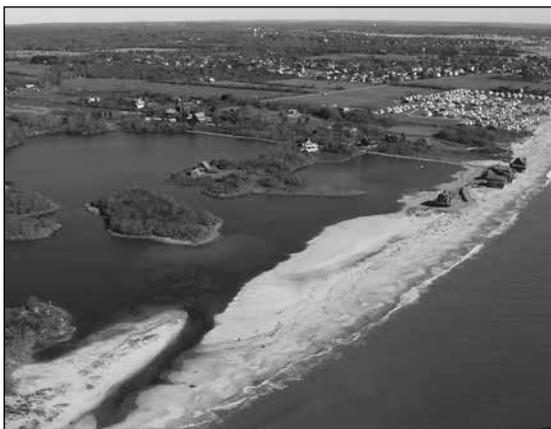
Figure 3. Aerial photo by S. Paton of US Fish and Wildlife Service taken several days after Sandy, showing overwashed sand on the coastal barrier in front of Cards Pond in South Kingstown. Note the location of the Browning Cottages at the right edge of the photo.

The landward migration of the Moonstone Barrier in South Kingstown is very apparent at the location of the historic Browning Cottages, where the barrier has eroded more than 120 feet since 1939 (Figures 3 and 4). Sadly, several of these cottages are being razed due to irreparable damage from Hurricane Sandy.

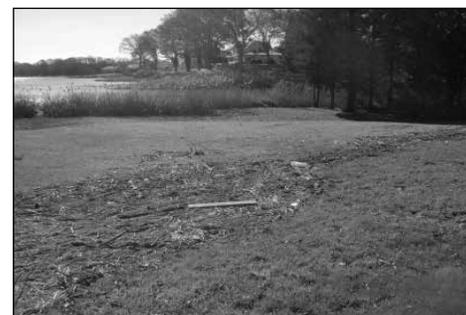
Figure 5. Photo from Professor Peter August showing a wrack line with debris from Sandy.

“wrack lines,” or lines of aquatic vegetation and debris deposited at the high tide line (Figure 5). University of Rhode Island Professor Peter August and Environmental Data Center scientists Chuck LaBash, Greg Bonyng, and Mike Bradley along with graduate student Erica Tefft collected GPS coordinates of the high water mark on pond-side properties and elsewhere along the RI coast. They took photographs, noted the direction of water flow, and recorded the landscape setting of the wrack line at each location. This effort will not only document the extent of flooding from Sandy in RI, but can also be used to validate, or ground-truth, GIS models of storm surge inundation.

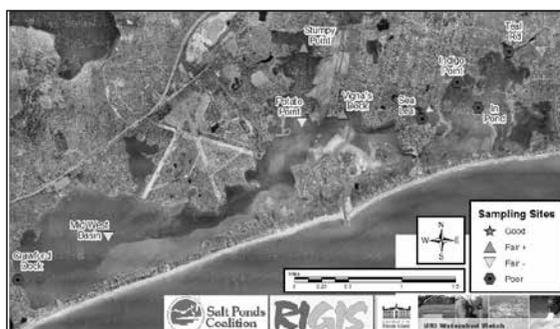
Figure 3 is a plot of average AHIs for Green Hill Pond sites. Water quality has been heavily impacted by dense housing development around much of the pond. Furthermore, exchange of pond water with clean ocean water is restricted by the channel to Ninigret Pond. In 2010, all four sites in Green Hill were in the poor AHI category. Two sites (In Pond and Teal Rd.) had slightly improved 2011 AHIs versus 2010, while the other two (Indigo Point and Sea Lea) had worse AHI scores. Trend lines for the data all had negative slopes, indicating declining water quality; however, at Sea Lea the decline was slight and there was a very poor fit of the regression line to the data.
