**Salt Ponds
Coalition**

The Tidal Page

News of the Rhode Island Salt Ponds

Winter 2012/2013

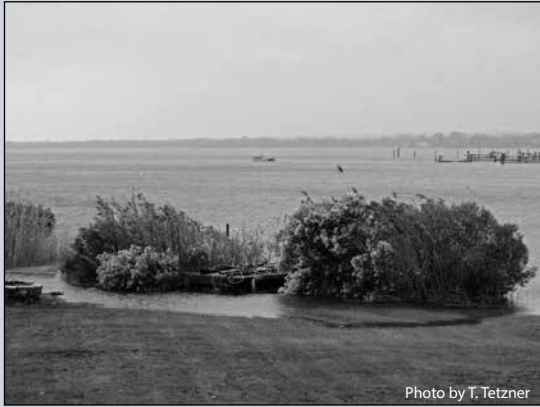
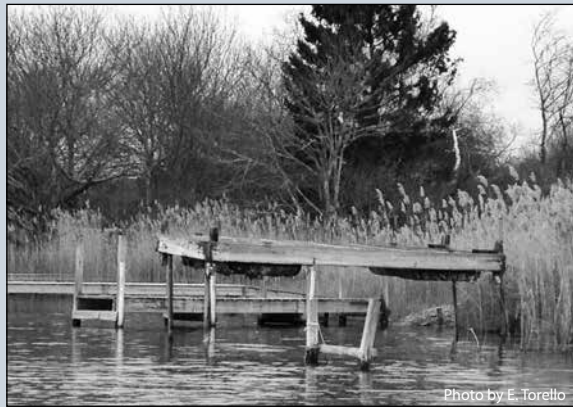
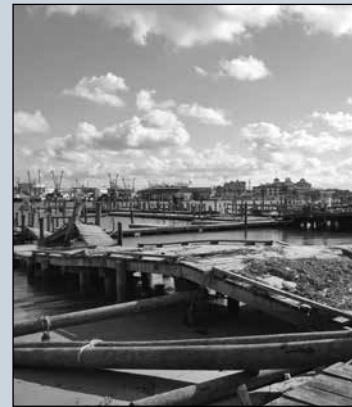
The high storm surge from Hurricane Sandy, on top of a full-moon spring tide, caused significant damage to private and commercial docks within Ninigret Pond. Center photo: Green Hill Pond. Right photo: Jim's Dock, Pt. Judith Pond.

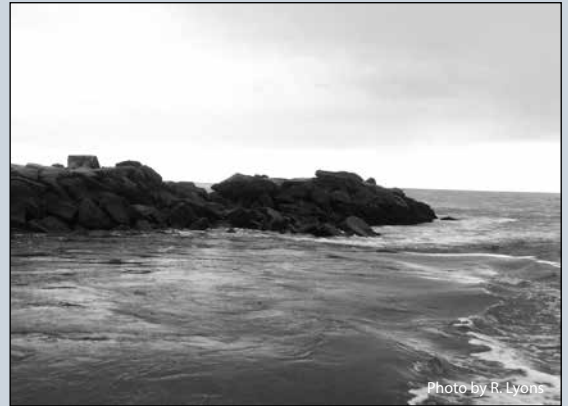
Photo by R. Lyons

Pounding storm waves pushed large rocks from the east wall of the Charlestown Breachway into the channel. FEMA funds are being sought to repair the damage.

More challenging and potentially more expensive damage to the Charlestown Breachway resulted from the pounding of storm waves against the east wall of the channel. According to Coastal Pond Management Commission chairman Rob Lyons, a number of rocks were pushed into the channel from the wall. This is causing parts of the wall to be nearly underwater at high tide, and the wall is no longer safe for fishermen to walk on. Charlestown and the State of RI are also applying for

FEMA funds to pay for the removal of the rocks from the channel and for the repair of the breachway walls.

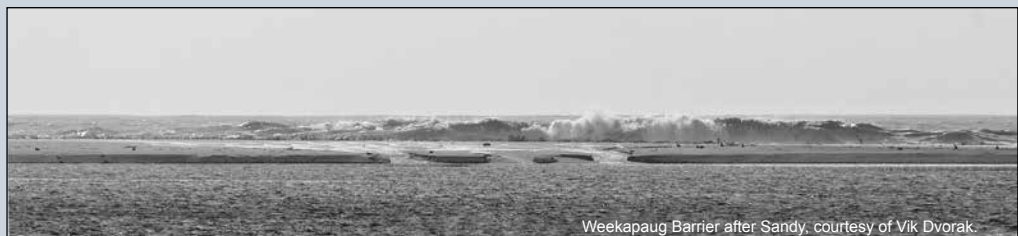
Weekapaug Barrier after Sandy, courtesy of VIK Dvorak

The photo below shows storm waves and overwash on the much flatter Weekapaug Barrier beach.

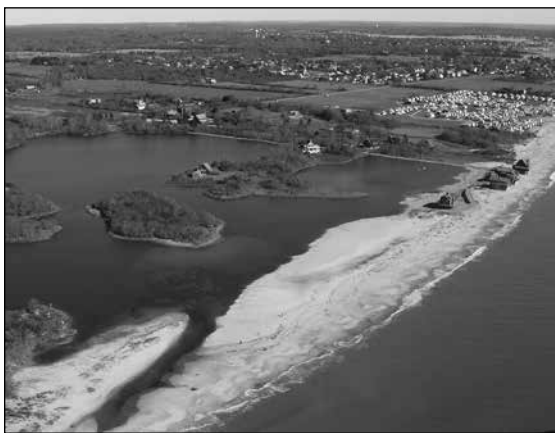
Figure 3. Aerial photo by S. Paton of US Fish and Wildlife Service taken several days after Sandy, showing overwashed sand on the coastal barrier in front of Cards Pond in South Kingstown. Note the location of the Browning Cottages at the right edge of the photo.

The landward migration of the Moonstone Barrier in South Kingstown is very apparent at the location of the historic Browning Cottages, where the barrier has eroded more than 120 feet since 1939 (Figures 3 and 4). Sadly, several of these cottages are being razed due to irreparable damage from Hurricane Sandy.

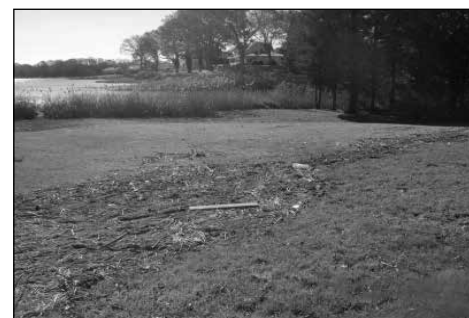
Figure 5. Photo from Professor Peter August showing a wrack line with debris from Sandy.

“wrack lines,” or lines of aquatic vegetation and debris deposited at the high tide line (Figure 5). University of Rhode Island Professor Peter August and Environmental Data Center scientists Chuck LaBash, Greg Bonyng, and Mike Bradley along with graduate student Erica Tefft collected GPS coordinates of the high water mark on pond-side properties and elsewhere along the RI coast. They took photographs, noted the direction of water flow, and recorded the landscape setting of the wrack line at each location. This effort will not only document the extent of flooding from Sandy in RI, but can also be used to validate, or ground-truth, GIS models of storm surge inundation.

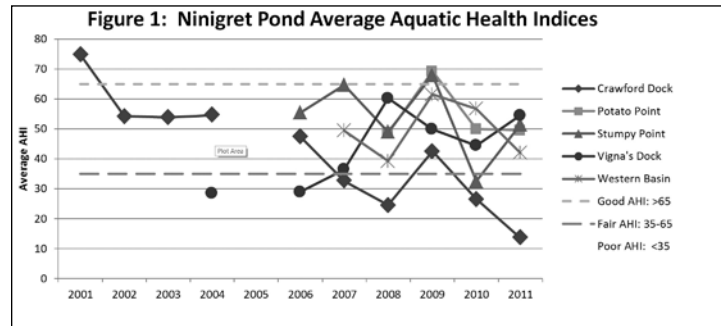
Ninigret Pond furthest from the breachway, has been sampled for more years than the other sites in Ninigret Pond. The AHI at the Crawford Dock site is in the "Poor"

AHI category--the worst water quality of any of the sites in this pond--and appears to be declining. A linear regression line of the AHI values at Crawford Dock has a slope of -4.8, with an r^2 value (correlation coefficient) of 0.83, indicating a strong fit of the data points to the regression line.

Figure 1 is a plot of average AHI values for sampling sites in Ninigret Pond. Each value is an average of the AHI values for individual data parameters at each site. Crawford Dock, at the far western end of

A possible cause of the poor water quality at this site is the tendency of winds to pile macroalgae on the shore adjacent to the dock. The decaying organic matter consumes dissolved oxygen (DO) and releases ammonium (NH_4^+) and

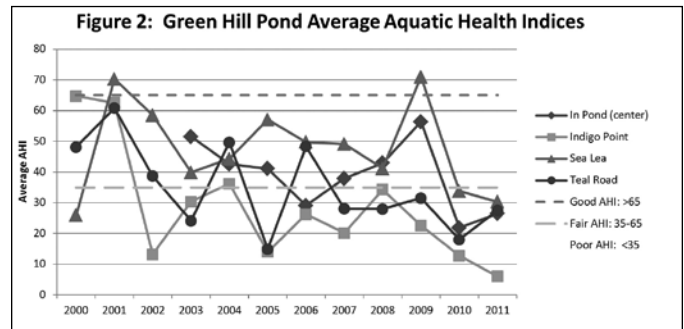
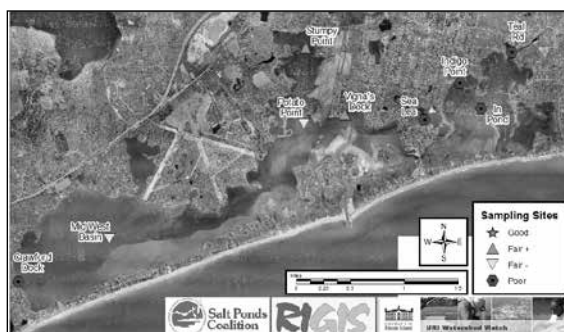
Figure 3 is a plot of average AHIs for Green Hill Pond sites. Water quality has been heavily impacted by dense housing development around much of the pond. Furthermore, exchange of pond water with clean ocean water is restricted by the channel to Ninigret Pond. In 2010, all four sites in Green Hill were in the poor AHI category. Two sites (In Pond and Teal Rd.) had slightly improved 2011 AHIs versus 2010, while the other two (Indigo Point and Sea Lea) had worse AHI scores. Trend lines for the data all had negative slopes, indicating declining water quality; however, at Sea Lea the decline was slight and there was a very poor fit of the regression line to the data.
